First Baptist Church
of Clarkston
Church of God

Clarkston Historic
District

Site No.
6-14

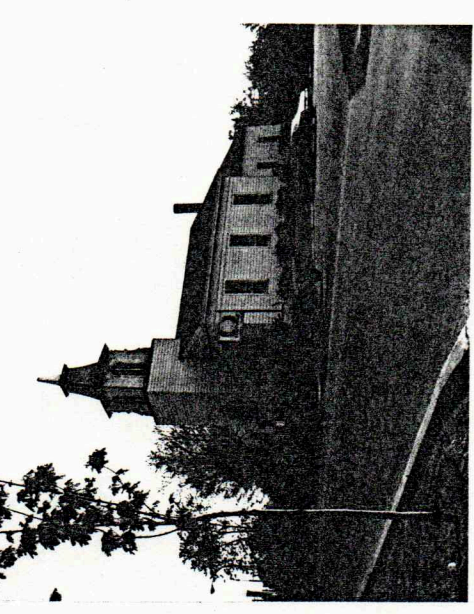
Photography: Neg. No. Roll #4, Frame #5

5/25/79
South and West facades looking Northeast

This clapboard over wood frame structure was built in 1847. In 1892, horse sheds were constructed on the southeast corner of the property while the adjacent house to the north was purchased in 1895 for use as a parsonage. An addition to the church was built circa 1912. In 1930, the original stacked stone foundations were removed and replaced with poured concrete pilasters with concrete block infill. The church was remodeled in 1938 including the alteration of the belfry. The stained glass windows of the auditorium were replaced in 1949 and a vestibule was added on the northwest corner circa 1950.
